Subject: Accessory drive on Renault 1.5 DCi engines.

Business Development

European Aftermarket

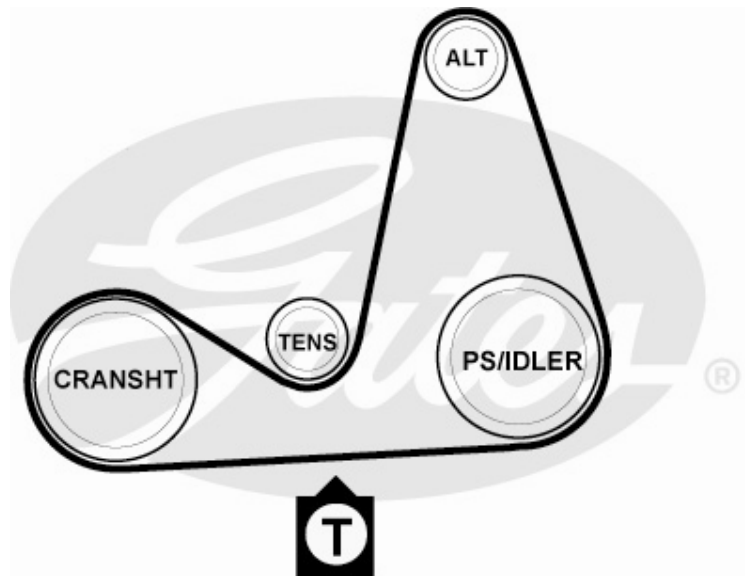
Fig.1

Measure the tension in the bottom span, between the crankshaft and power steering pump (or idler for cars without power steering) (Fig.1).

When measuring the belt tension with the STT-1, key in "8", "180" (virtual span of 180 mm). When measuring with the Krikit[®], tension has to be 70 Kg.

Now tighten the 2 bolts (36 Nm).
Rotate the engine 2 revolutions clockwise.

Check the tension and adjust if needed.
Re-install all removed parts.
